Harvey A. Pugh House (William Saxton House)
East side of N. Broadway St .
Montour
Gem County
Idaho

HABS No. ID-41

HARVEY A. PUGH HOUSE - PUGH ELEVATOR, MILL AND WAREHOUSE
(William Saxton House)

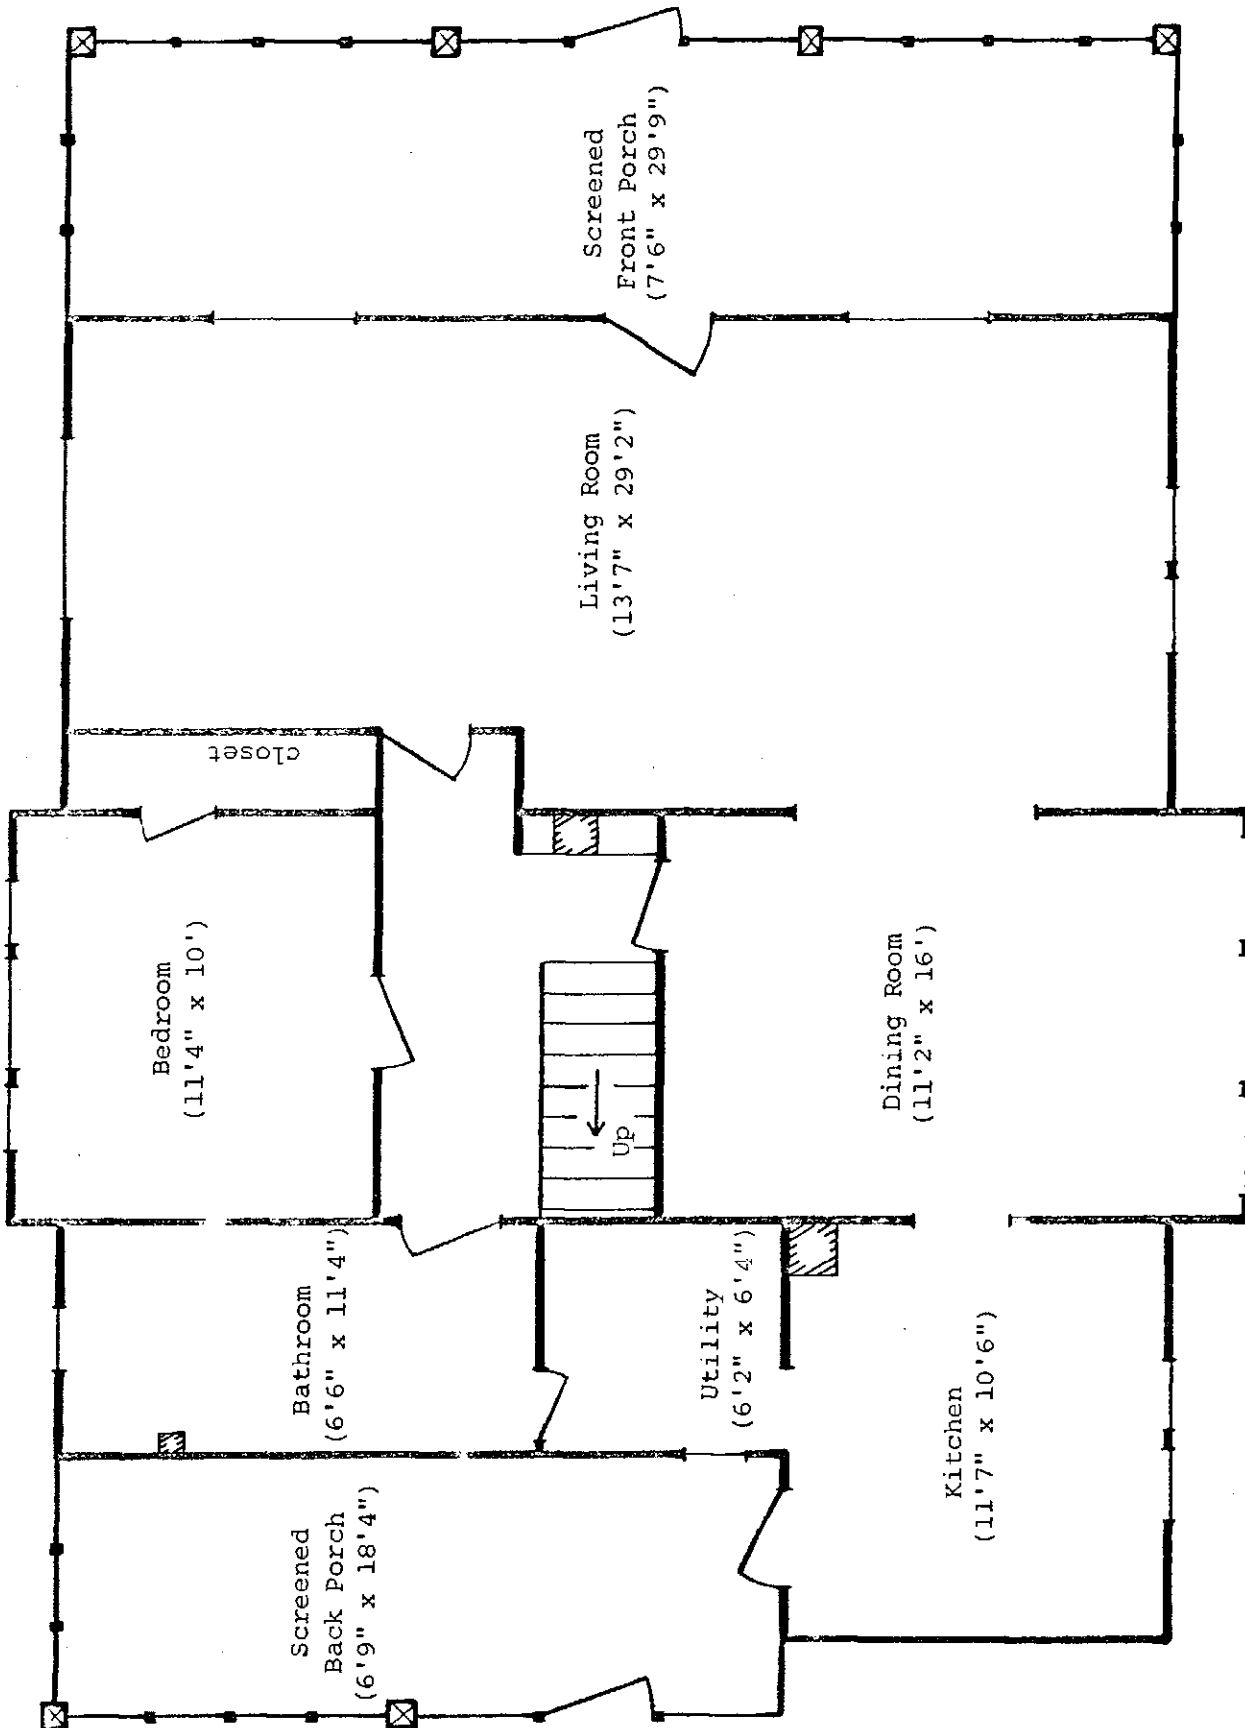
HARVEY PUGH HOUSE
approx. 3/16 scale

1. Architectural merit and interest: The house is an example of the simple vernacular adaptation of the bungalow style mixed with a few details of the Queen Anne style which preceded it.
2. Condition of fabric: Good
3. Summary description: One and a half stories, approximately 31 feet by 44 feet, rectangular plan.

1. Foundations: Of natural dark gray concrete with a smooth cement finish, the foundations vary from 4 to 10 inches in height. The foundation is continuous at the porches as well as at the house. There are several irregular vertical cracks through the foundations.
2. Wall construction: At the base of the wall is a 9½-inch wide wooden beltcourse capped with a watertable molding. The walls are clapboards with 2 ¾-inch exposure and in good condition.
3. Structural system: The house is of wood-frame construction

5. Doorways and doors: The doors are six-panel doors. Door frames are flat, 4-3/8 inches wide at jambs and 4 3/4 inches wide at the heads. A 1/2-inch thick projecting bead molding is at the lower edge of the head trim. Window trim matches the door trim. The use of the bead molding is carried over from the Queen Anne style. The woodwork in the hall is stained dark and given a glossy finish. Elsewhere, woodwork is painted.

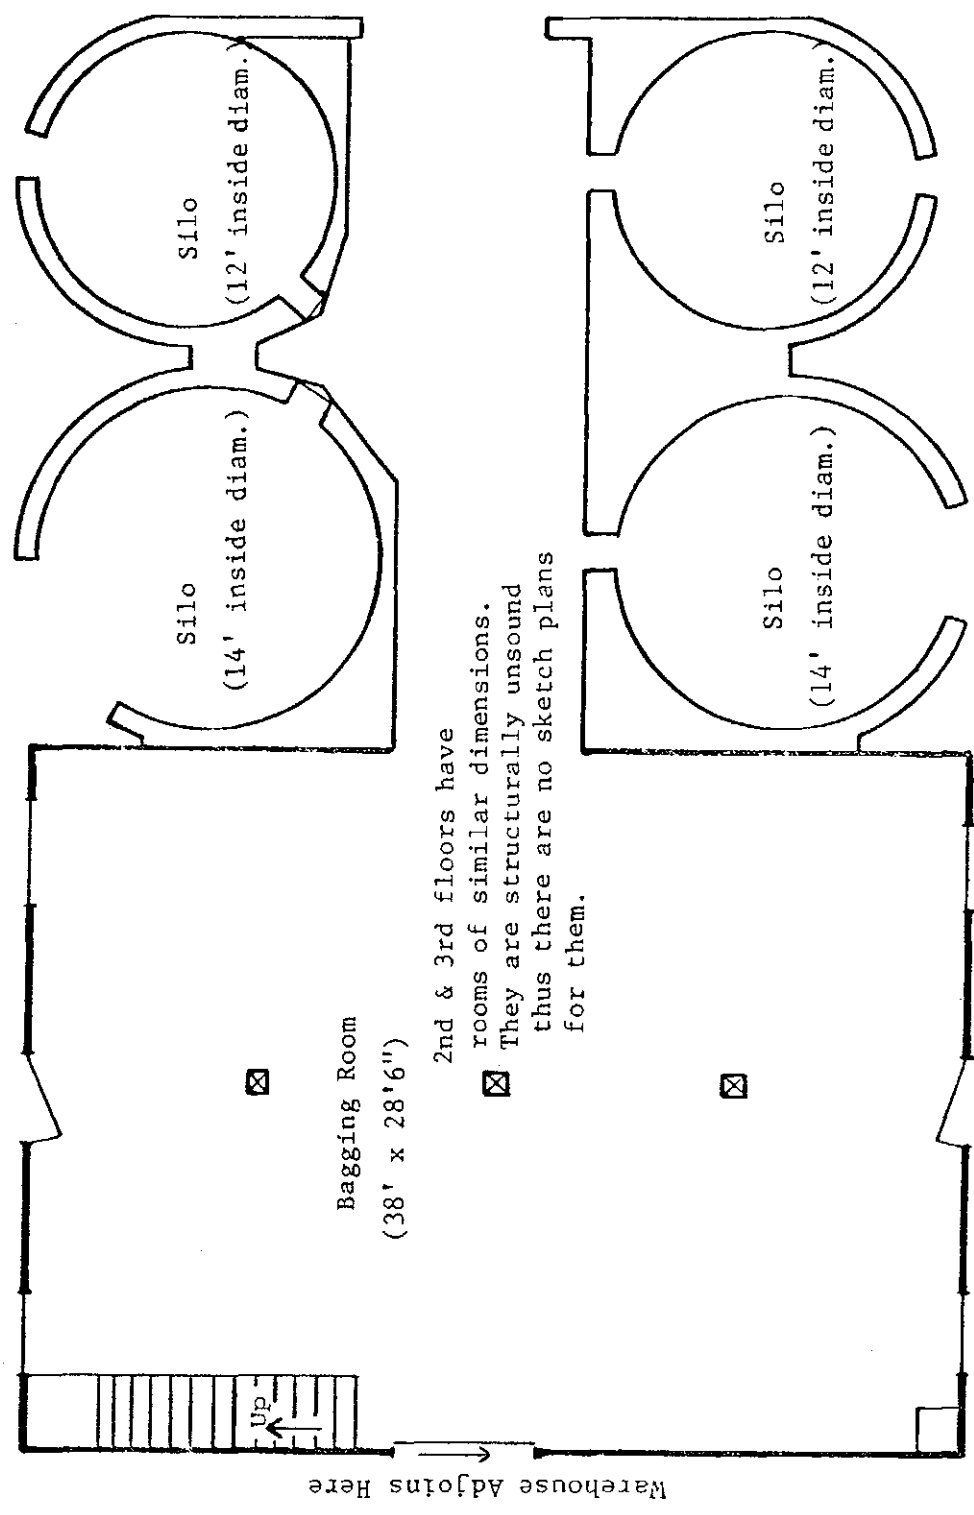
PUGH ELEVATOR, MILL & WAREHOUSE NA
Elevator & Mill - Ground Floor
approx. 1/8 scale

Elevator & Mill attach here

1. Architectural merit and interest: The structure is of interest as an example of a small elevator, mill, and warehouse building making use of reinforced concrete.
2. Condition of fabric: The concrete work of the elevator is in fair condition (its exterior surfaces show weathering) and that of the mill is in good condition. The wooden construction of the elevator is in good condition; that of the mill in fair to poor condition. The warehouse is, in general, in good condition.
3. Summary description: The building has three parts which fit into a long rectangle 146'x40'. The elevator comprises the 31 feet farthest from the street; the mill, the middle 30 feet; and the warehouse the 84 feet nearest to the street. The elevator is approximately the same height as the mill which has three stories above a raised basement; the warehouse is one story and lower.

2. Wall construction: At the elevator, the cylindrical bins have door-sized openings broken through their walls at ground level. Here the concrete of the walls is 6 inches thick and is reinforced with twisted square bars $7/8$ inches in diameter ($5/8$ inch on a side of the square) placed vertically at 24 inches on center, and $5/8$ -inch-diameter bars spaced horizontally irregularly from 10 to 14 inches on center. The round bars are outside of the vertical bars. Two layers of twisted wire mesh are placed outside of the vertical bars and within the horizontal bars. The inner of these meshes is 6 inches square; the outer is 6 inches by $2\frac{1}{2}$ inches (the latter dimension taken vertically). The exterior surface of the bins is covered with $\frac{1}{2}$ -inch-thick stucco, coated with flaking white paint. The stucco is quite hard, not weathered; but much of it has fallen off the walls. Here the concrete is exposed and quite weathered, allowing the river-gravel aggregate of about 2-inch maximum size to be seen. Also visible in the concrete are what appear to be the marks of the many separate pourings of concrete. I do not think these lines are the marks of the forms, because the weathering often differs at adjacent "bands," as though the consistency of the concrete varied in them. The lines between these pourings are not level lines and are quite pronounced.

4. Porches: None
5. Chimneys: There is a brick chimney built within the southwest corner concrete walls of the mill.
6. Openings, doorways and doors: At the east end of the elevator is the framed opening for a large door, but the door is missing. The frame is wood.

In the mill there are windows at each of the three stories and the basement. The first and second story windows are 6/6 sash, all broken and some removed. The third-story windows have been removed, and the basement openings have
